Barton to New Holland Tidal Flood Alleviation Scheme

Current and Future Tidal Flood Risk

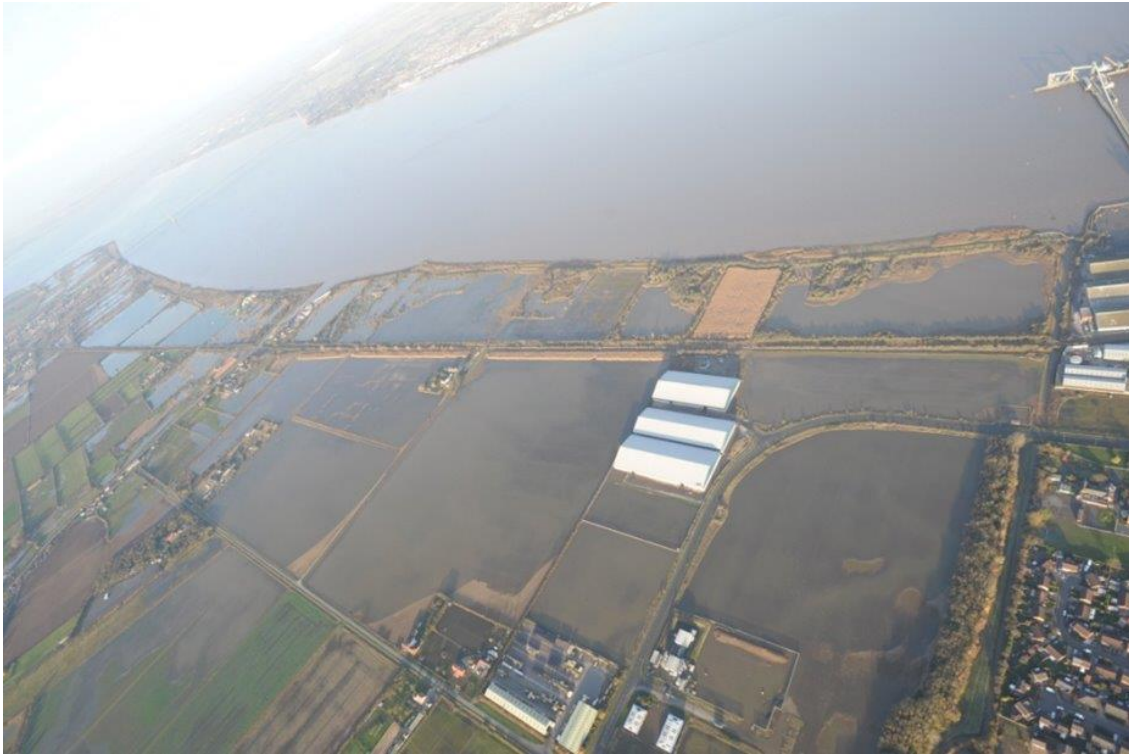
In New Holland 6 homes were flooded and many businesses too including timber workshops and warehouses, industrial units, grain sheds, school grounds and railway lines. Nearly 600 hectares of land was inundated between Far Ings and New Holland

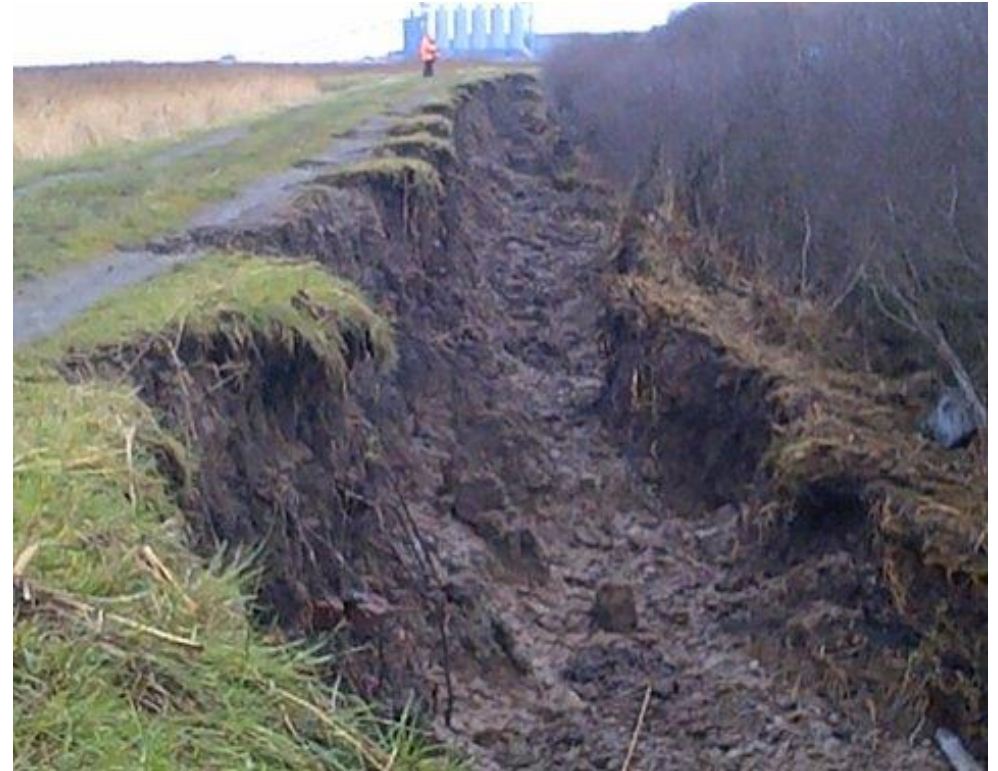
Widespread damages to embankments and footpaths towards New Holland

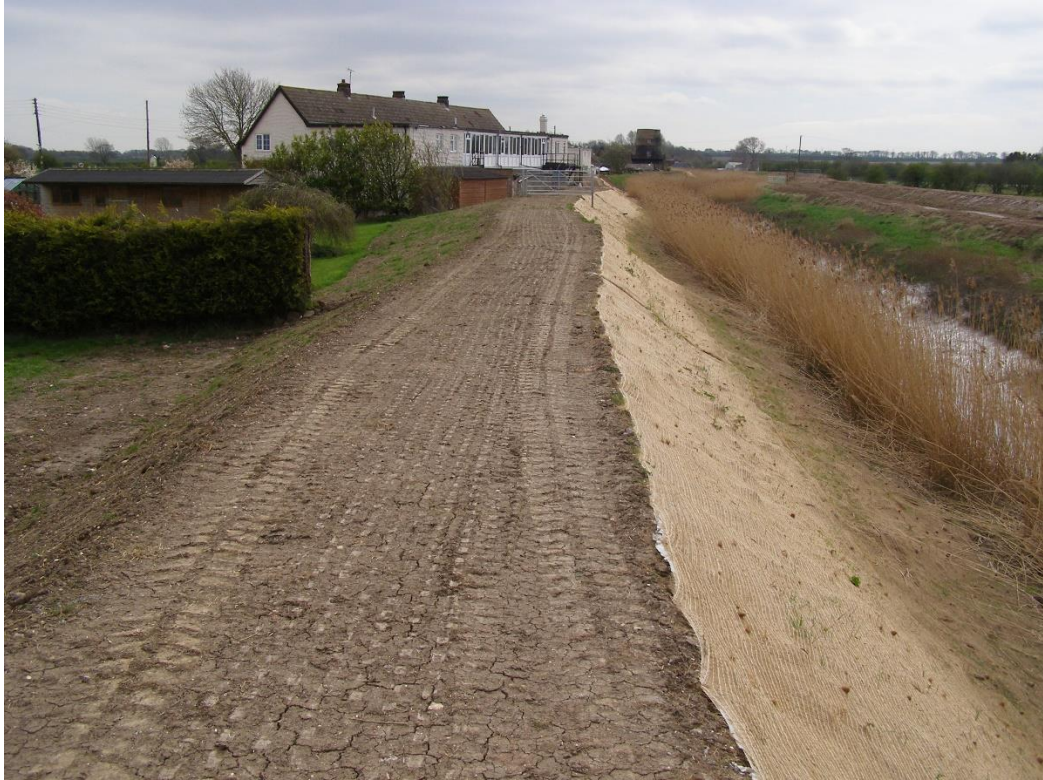
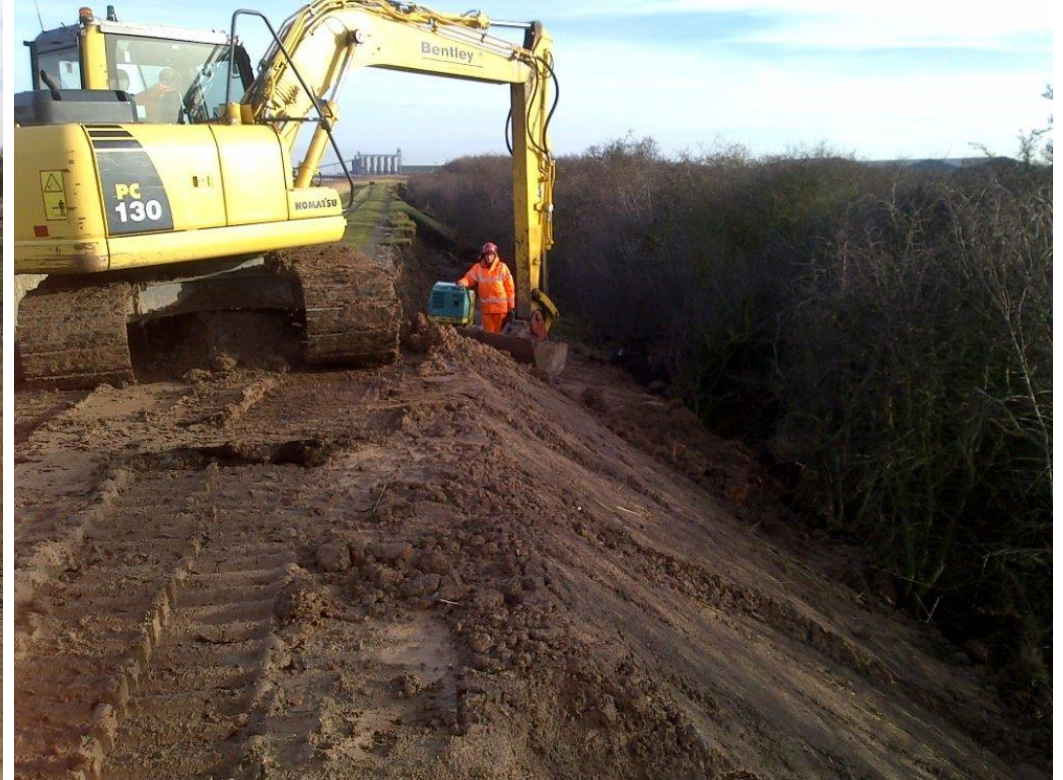
South Humber Bank Repairs (Between Barrow Haven and New Holland):

- £2.0 Million repair programme between December 2013 to September 2014
- Extensive repairs to Barrow Haven embankments were undertaken up to Spring 2015 (Left Image)
- Repairs completed on risk-based priority order
- 19km of overtopping with 3.5km of sever scouring
- 13,000 tonnes of clay were used to bolster flood banks
